## Training Field/Winthrop Square Community Update

March 10, 2015

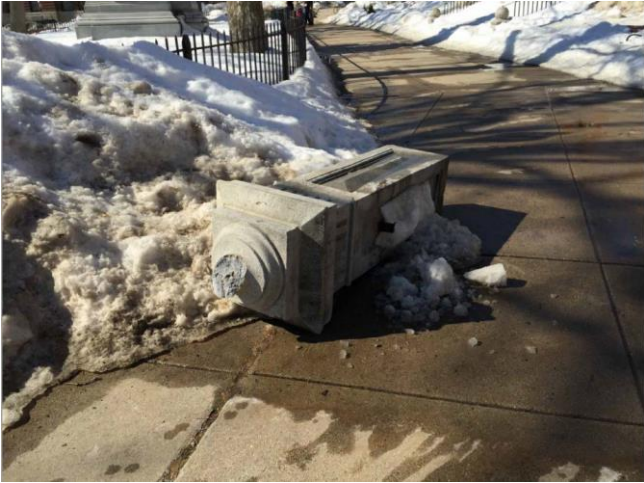
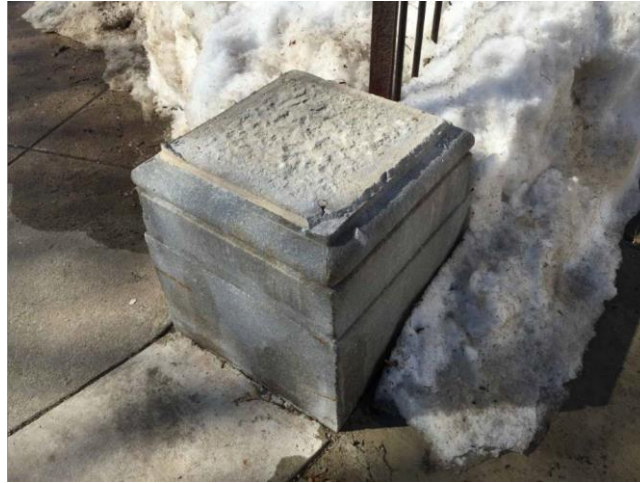
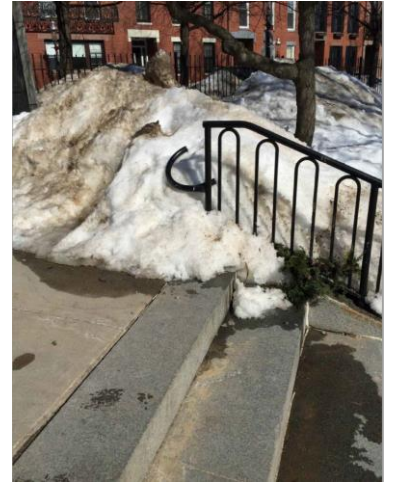
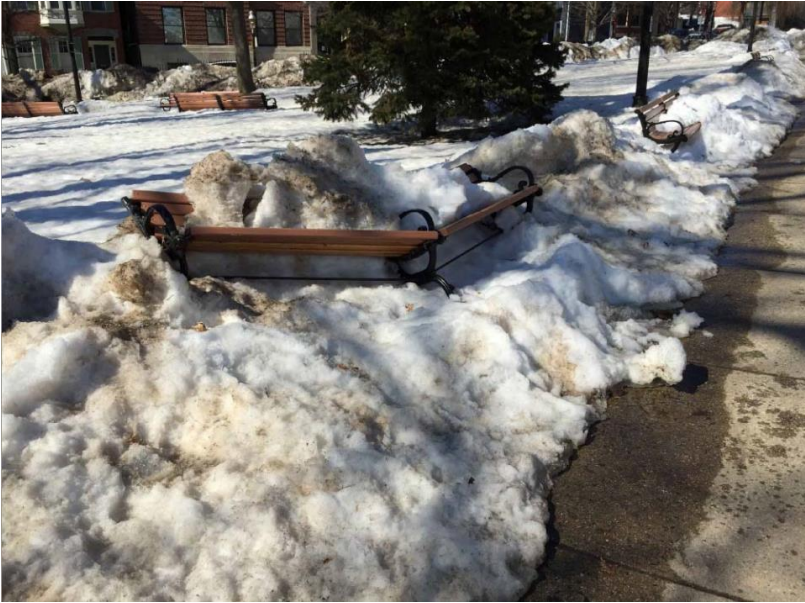
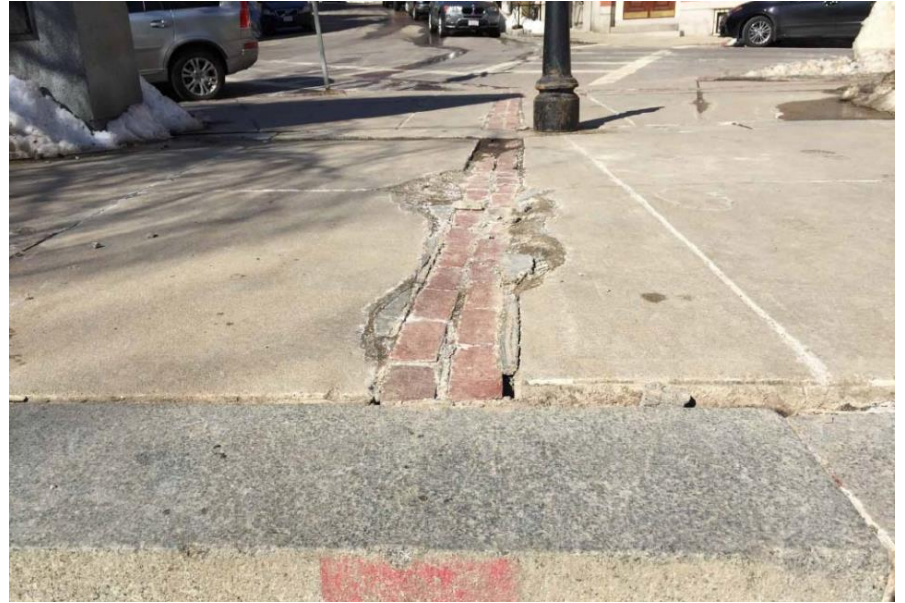
Winter damage

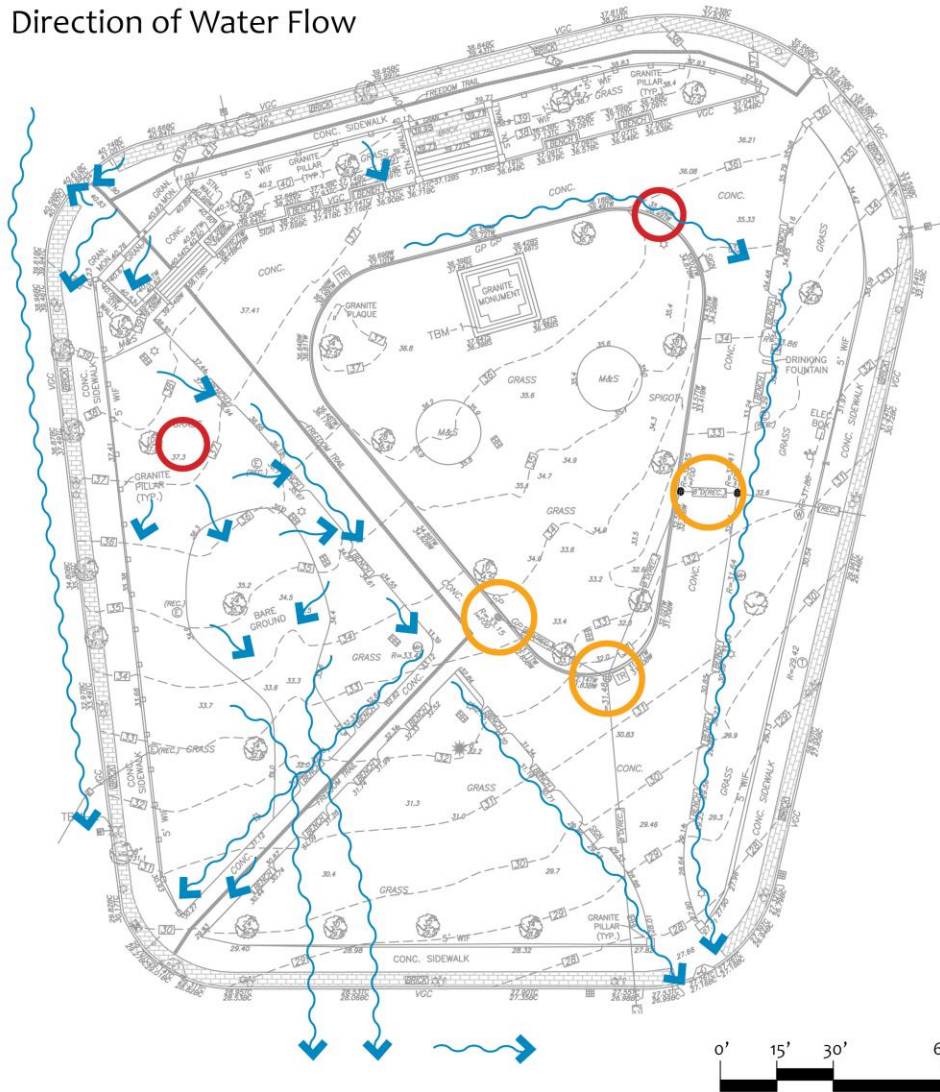
Direction of Water Flow

Site Analysis: Drainage/Erosion

- Add catch basins:
  - in key locations to capture stormwater before it causes erosion.
  - to prevent drainage across walks that causes icing problems.

○ Clean park catch basins.

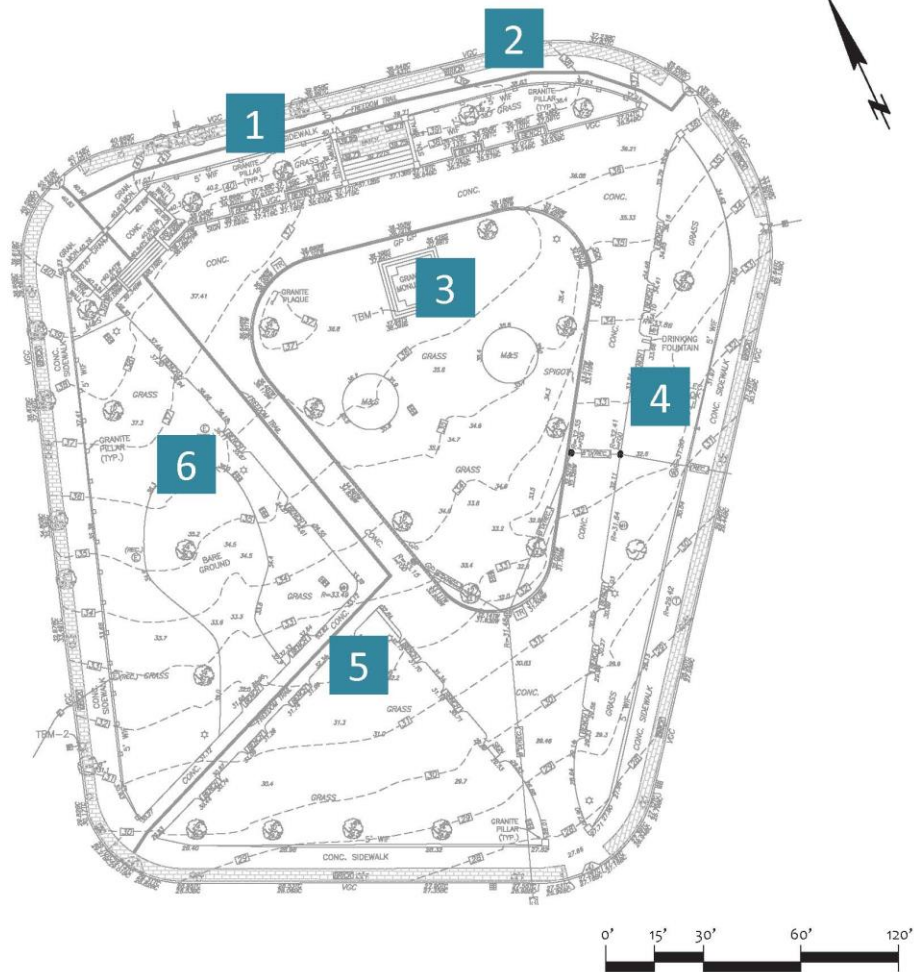
## Soil Health Test Areas

- Two of the areas (1 & 3) received an **overall quality score** of **medium** with the remaining four areas receiving a **low** quality score.
- All areas have **good stable aggregates** and high available water capacity.
- Surface (0 - 6" deep) and subsurface (6 – 18" deep) soils are **significantly compacted** around site.
- Soil **microbial activity** is **marginalized** around site due to low amount of active carbon (fresh organic residues).
- The **amount of heavy metals** in all areas is **below** the **maximum allowable concentrations** for garden soil.
- Many areas exhibit signs of **soil erosion and exposed roots**.

Address soil compaction issues through:

- Air spading
- Vertical composting
- Radial trenching
- Soil Amendments

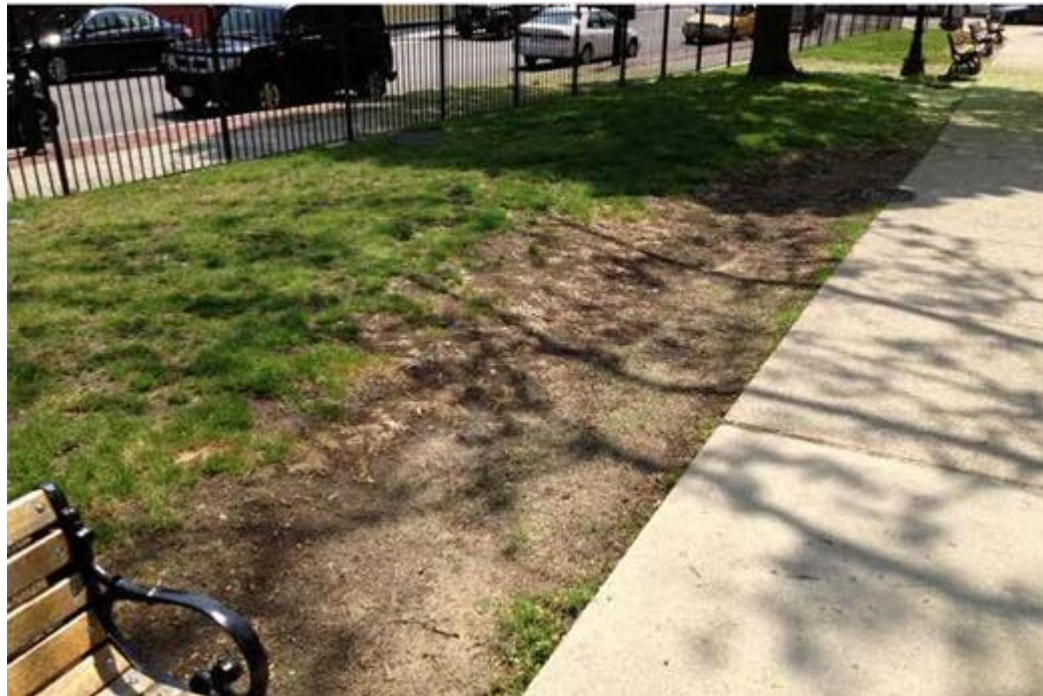
Recommendations: Soil

## Observations: Soil

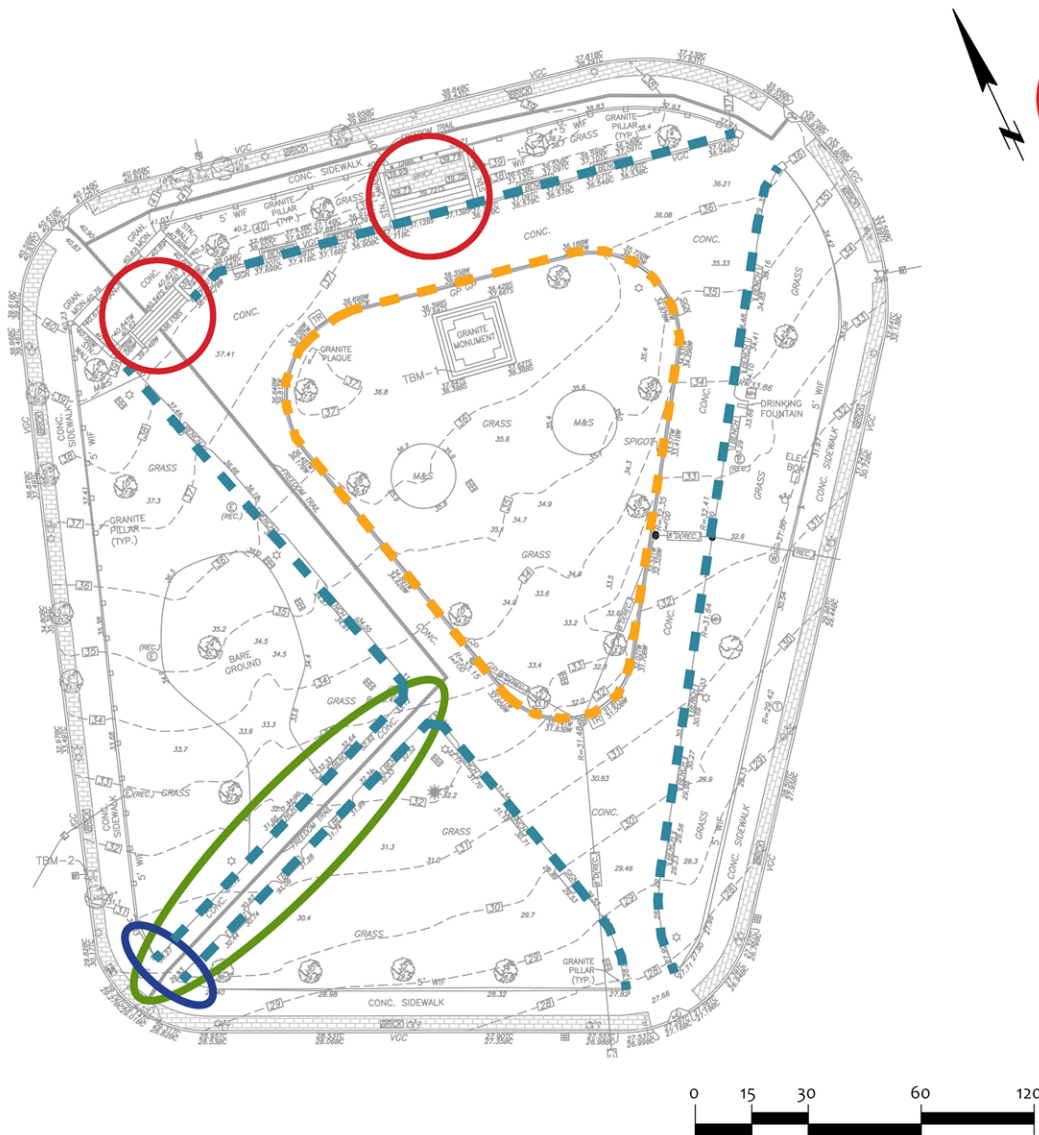
Site Analysis: Hardscape (pavement, curbs, steps)

- Study settlement & cracking at granite steps.
- Replace sealant on steps if required.

Replace interior fence concrete curb with granite.

Add low granite curb along walks to direct stormwater and define lawn edges.

Widen southwest diagonal path to 12' to allow snow plowing.

Add pillars to identify southwest entrance as similar to other entrances.

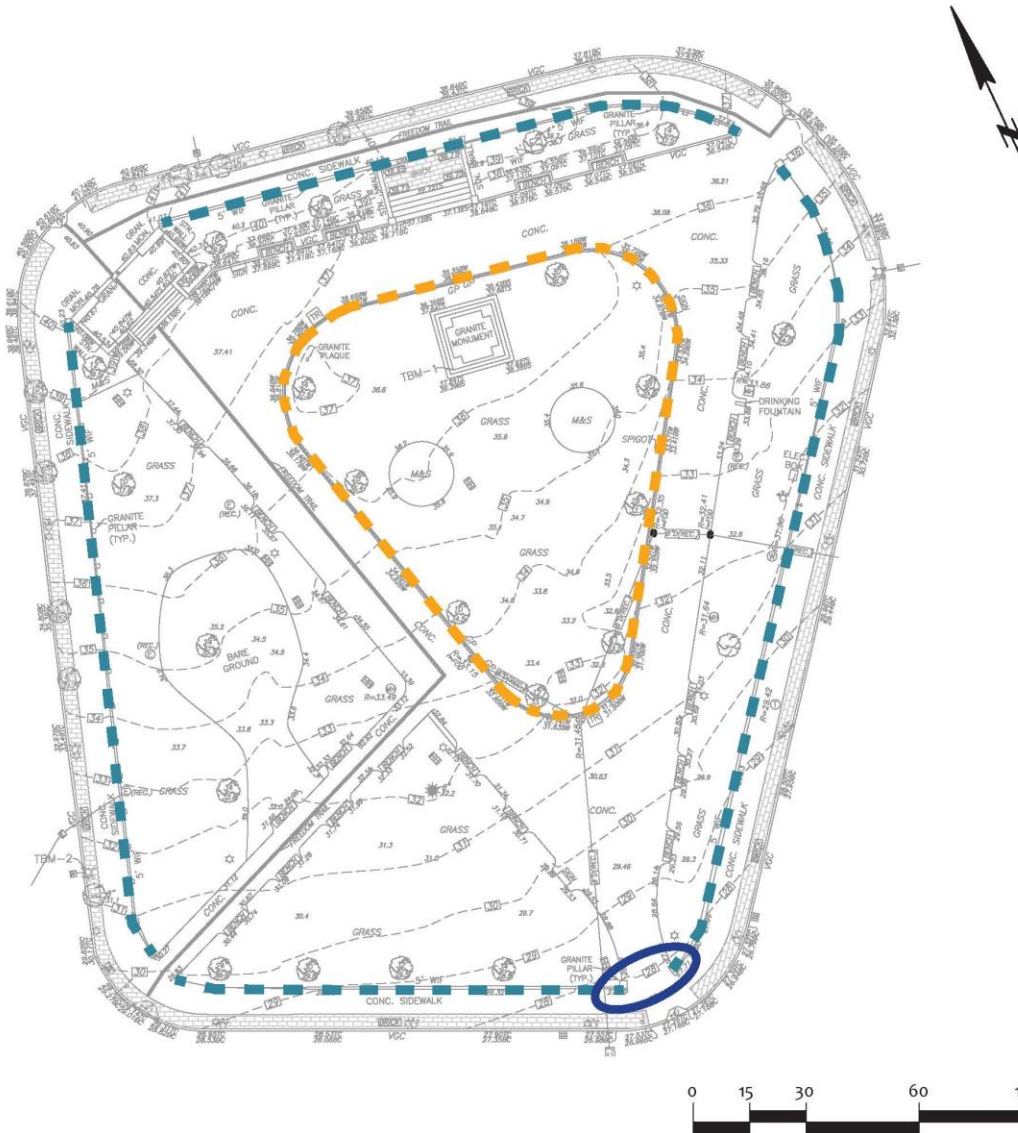
Site Analysis: Historic Features (monuments, tablets, fencing)

- Replace exterior fence with historically appropriate fence, and reconsider curb base in northeast corner of the park.
- Replace interior fence with historically appropriate fence: reconsider curb base.
- Replace missing granite urns on top of southeast pillars, and remove paint from base of pillars.

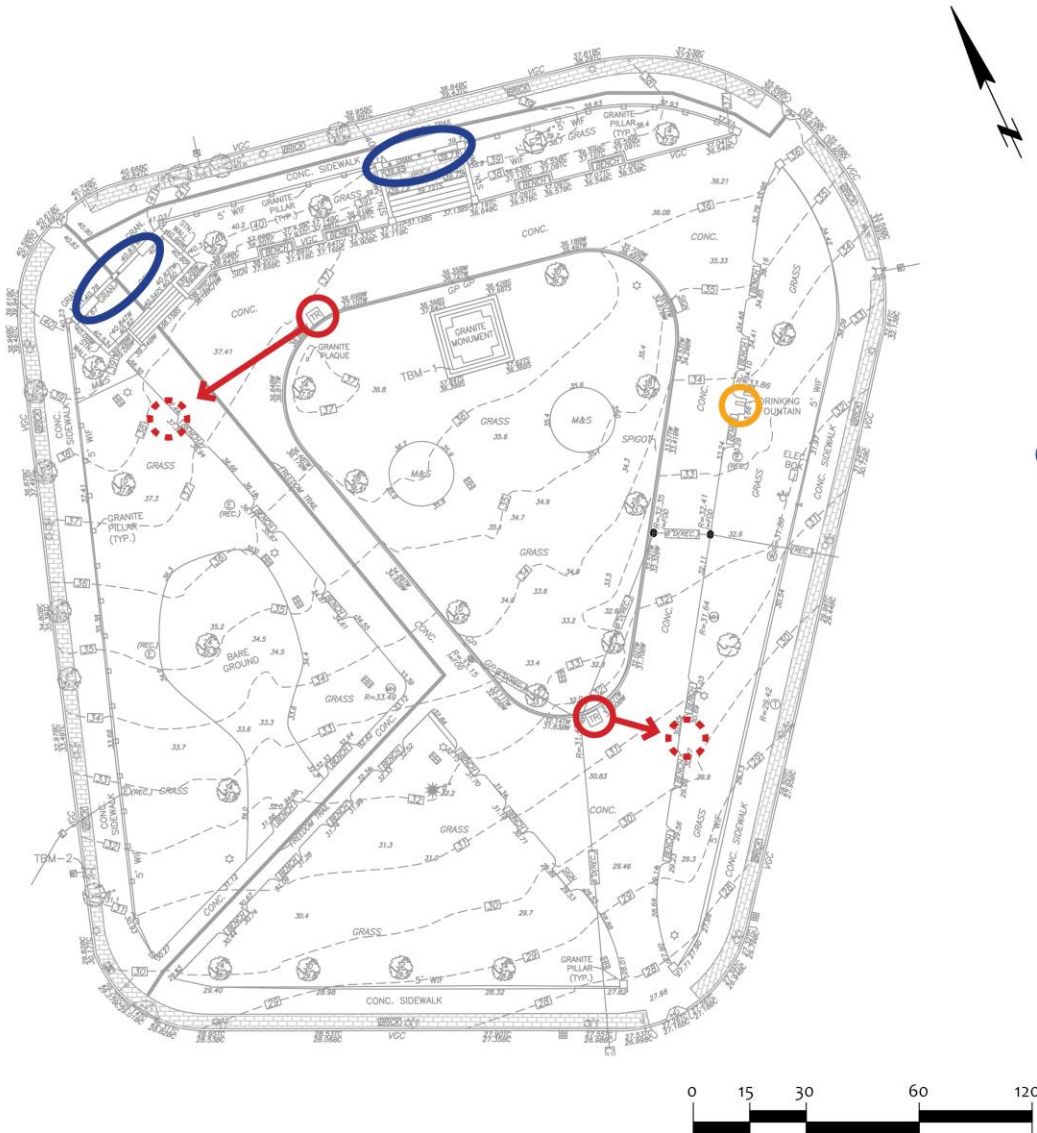
Site Analysis: Park Furnishings (benches, trash receptacles, signage)

- Paint light poles black.
- Paint stair railings.
- Refinish wood slats on benches or consider replacement with wood that does not need varnish.

Replace cast iron bollards near steps.

Install new accessible drinking fountain: cast iron, painted black, drained to dry well or sewer.

Move trash receptacles to less visually prominent locations, and replace with new solar compacting models.

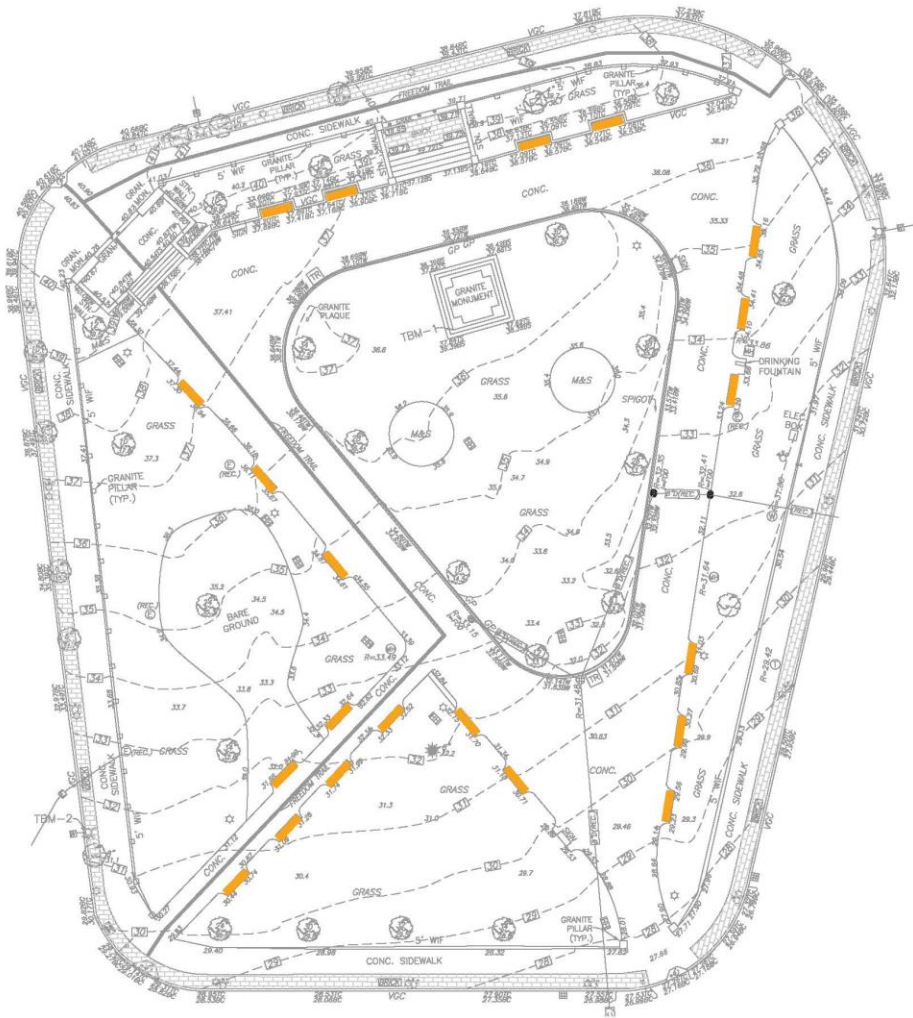
Site Analysis: Use, ADA Considerations

— Add companion wheelchair space beside benches.
