37 Winthrop Street (1875-85)

From Boston Landmark Commission's Charlestown Historic Resources Study 1981*:

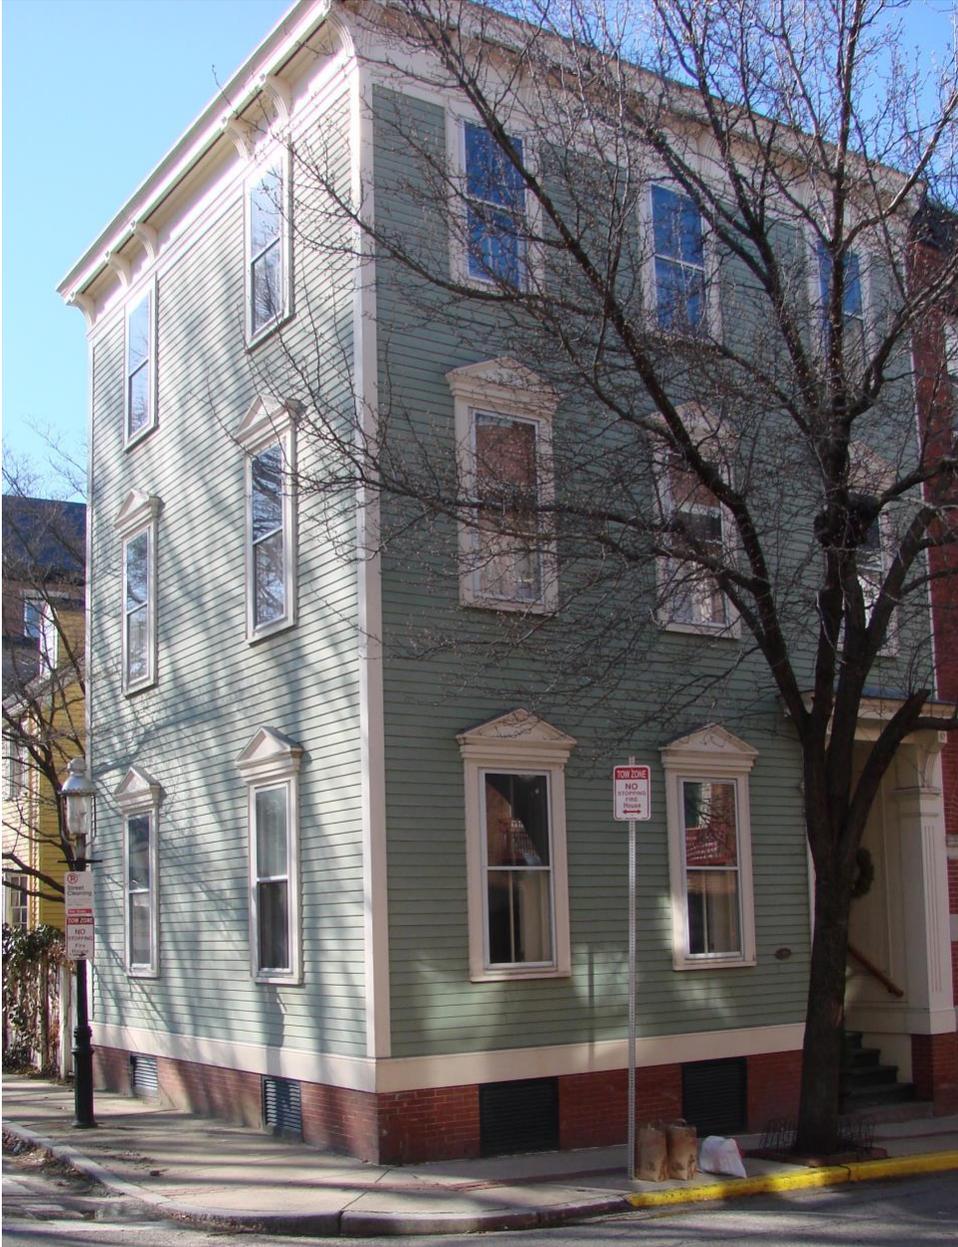
Number 37 Winthrop Street is an attractive example of late 1870s-early 1880s single-family Italianate wood frame vernacular houses.

It is prominently sited at the corner of Common and Winthrop Streets overlooking the Training Field/Winthrop Square. It has a side hall plan with three bays, and rises three stories from a brick basement. Narrow corner boards accent the edges of the house, and a broad baseboard runs between the basement and clapboards. The house has a flat roof with an overhanging cornice. The cornice has curved brackets, which are decorated on their undersides with incised lines, and circular bosses at their small square-top ends. There is a two-story ell at the rear.

The house has a deeply recessed side entrance with five wooden steps leading to transom-topped double multipaneled front doors. The entrance is framed by Doric pilasters, each with three incised grooves. The door hood has curved brackets with a shallow hip roof. The first and second floor windows are fully enframed and pedimented.
