7-17 Trenton Street (circa 1868-1870)

From Boston Landmark Commission's Charlestown Historic Resources Study 1981 (E. W. Gordon, Consultant)*:

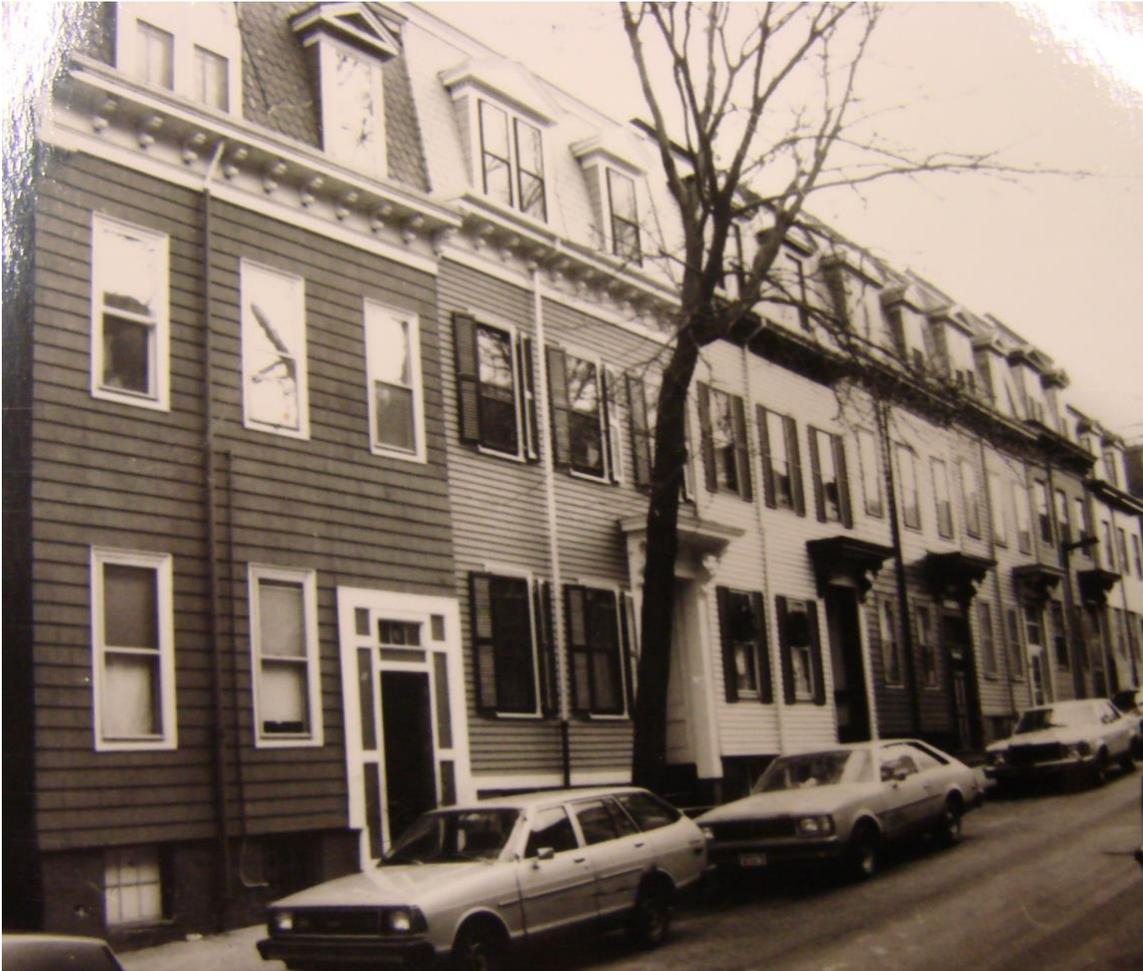
17- 7 Trenton Street

Numbers 7-17 Trenton Street is a row of five, two story wood frame Italianate/Mansard houses. They have a variety of surface treatments including wood shingles, clapboards, and aluminum siding. The houses have three bay main façades, side hall plans, and low brick basements. They have deep-bracketed cornices and mansard roofs with slate, scallop-shaped shingles, and double and single pedimented dormers.

Their entrance enframements consist of paneled pilasters and pendant-ornamented, bracketed door hoods. They have deep entries with paneled sidewalls, and inner doors surmounted by transoms. The windows are simply and fully enframed, with various sash configurations. Numbers nine and 15 are the most intact in terms of fabric, elements, etc.

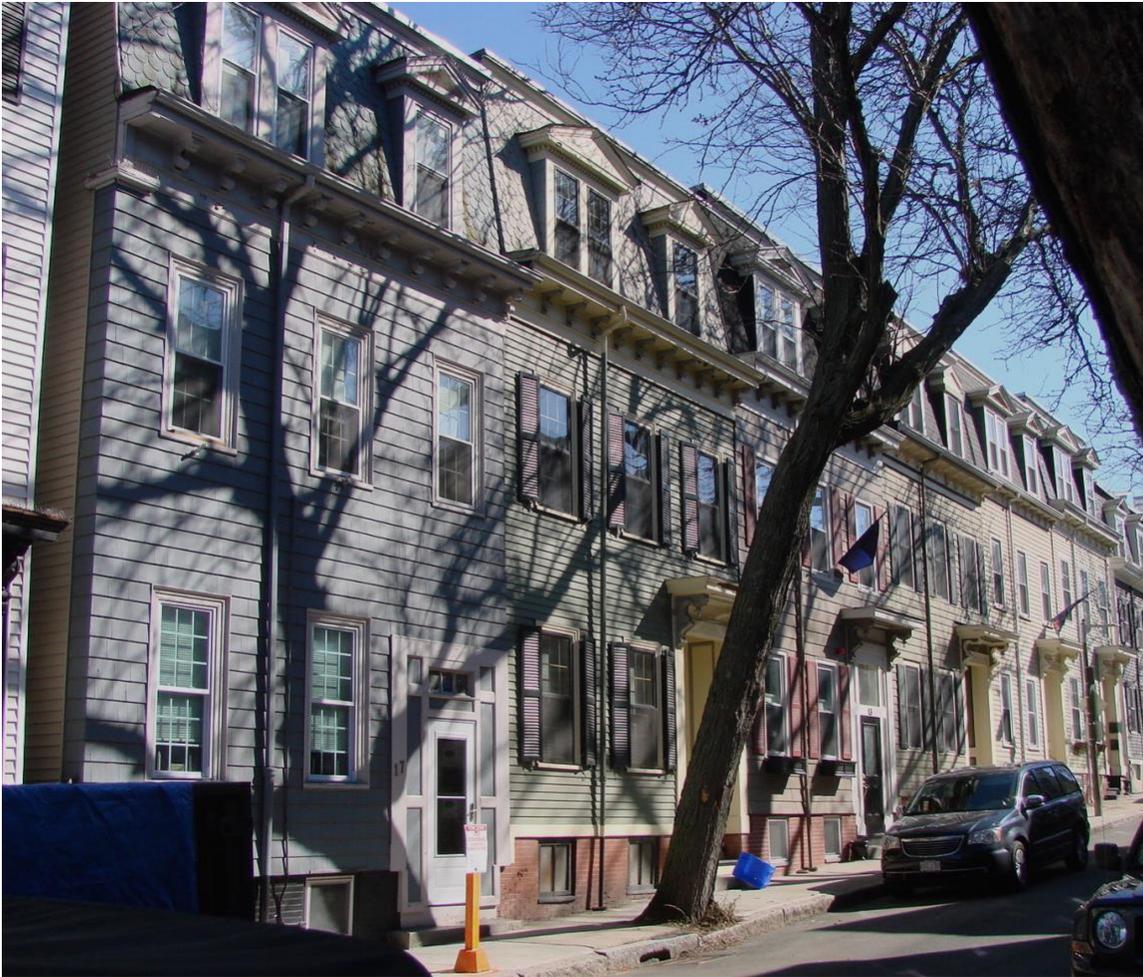
17- 7 Trenton Street

Much of Trenton Street's mid-19th century charm is dependent on the rhythmic repetition of this Mansard/Italianate row's bracketed door hoods, deep-bracketed cornices, and pedimented dormers. Architecturally, numbers 7-17 Trenton Street is an attractive example of late 1860s Mansard/Italianate row housing. This row retains integrity of siting, and form, if not always materials.
