72 High Street (1863-1864)

From Boston Landmark Commission's Charlestown Historic Resources Study 1981 (E. W. Gordon, Consultant)*:

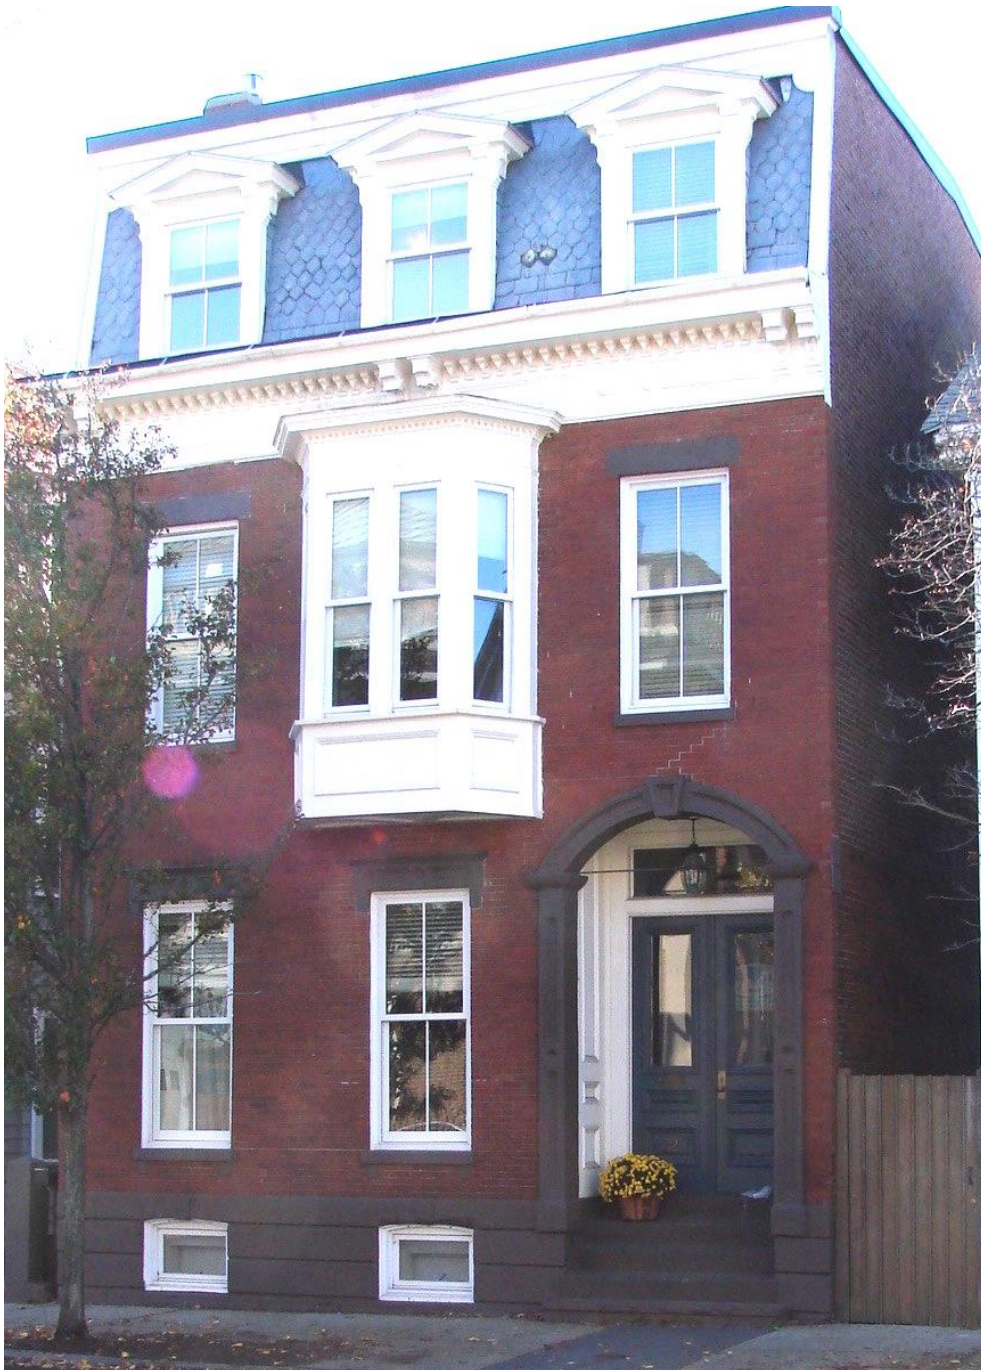
Number 72 High Street is a red brick Italianate/Mansard townhouse with a granite block basement and three bay main façade. A bay window projects from the east wall.

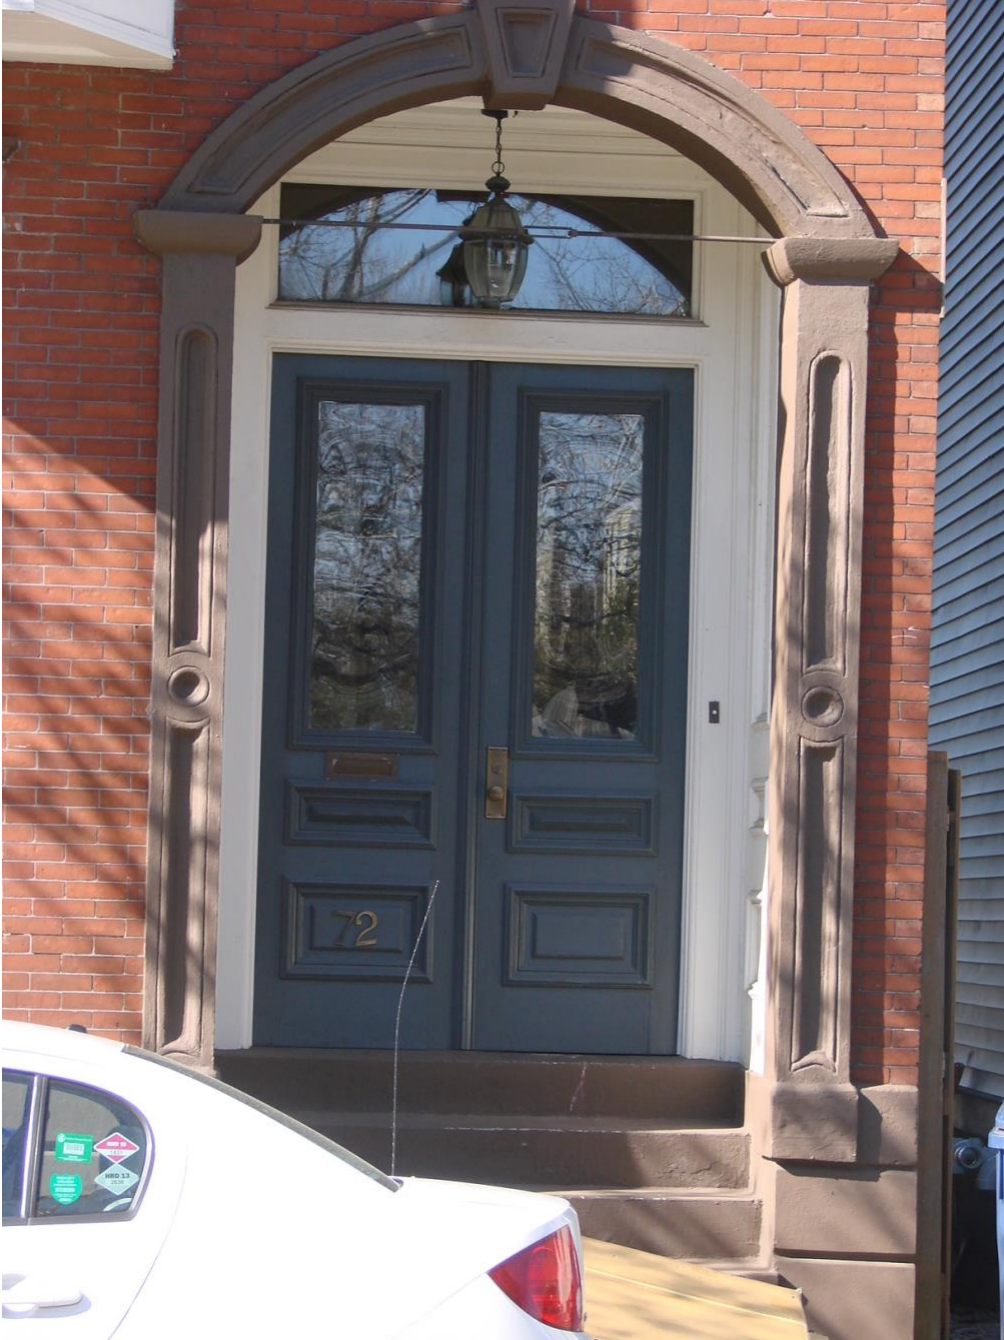
72 High Street entry detail

The house has a distinctive, recessed, brownstone entrance arch and multi-panelled pilasters. Still intact are the original double doors, and a transom. The windows have brownstone enframements with cornice-headed lintels with circular and rectangular panels, on the first floor. The second floor windows have simple rectangular brownstone sills and lintels. In the center of the second floor's main façade is an oriel with apron panels and dentils at its cornice.

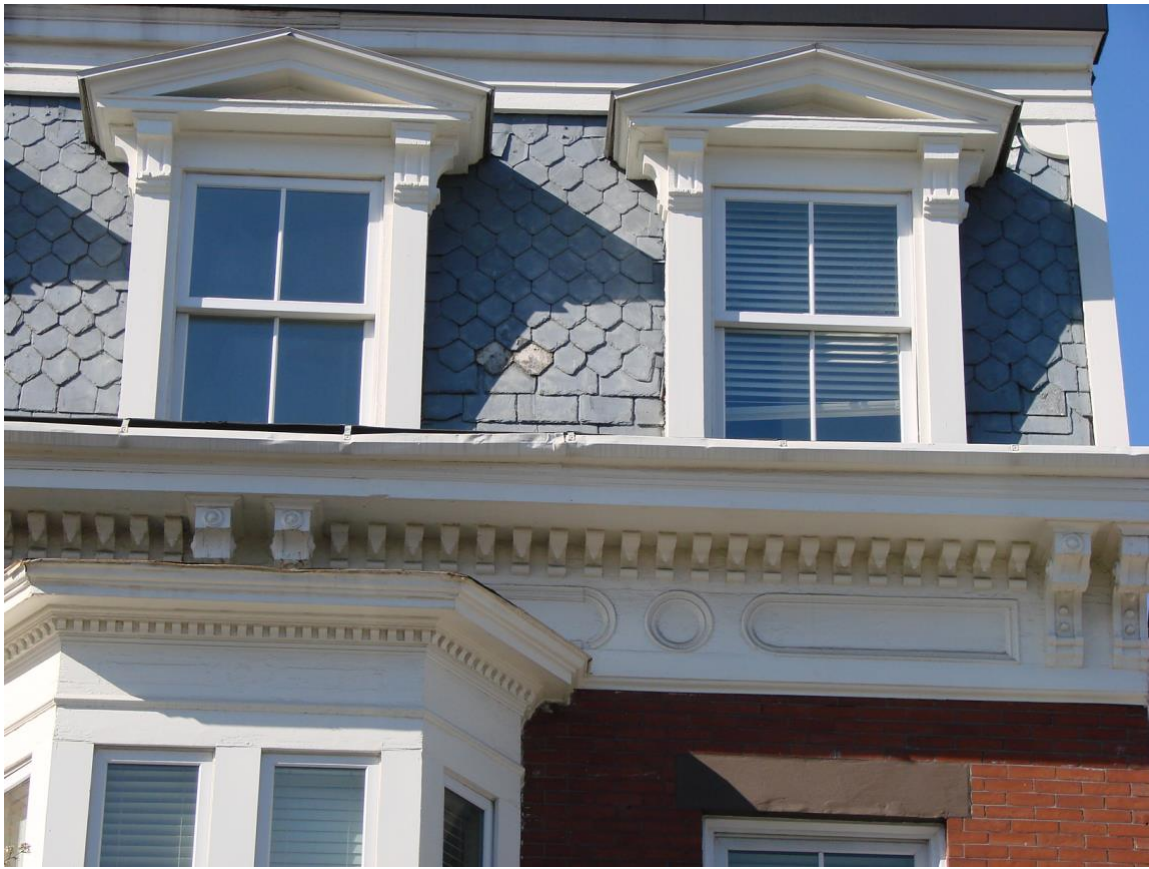
72 High Street Cornice, roof detail

The lintel detail all of the first floor windows is repeated on a fascia board of the cornice with large paired brackets flanking rows of smaller brackets.

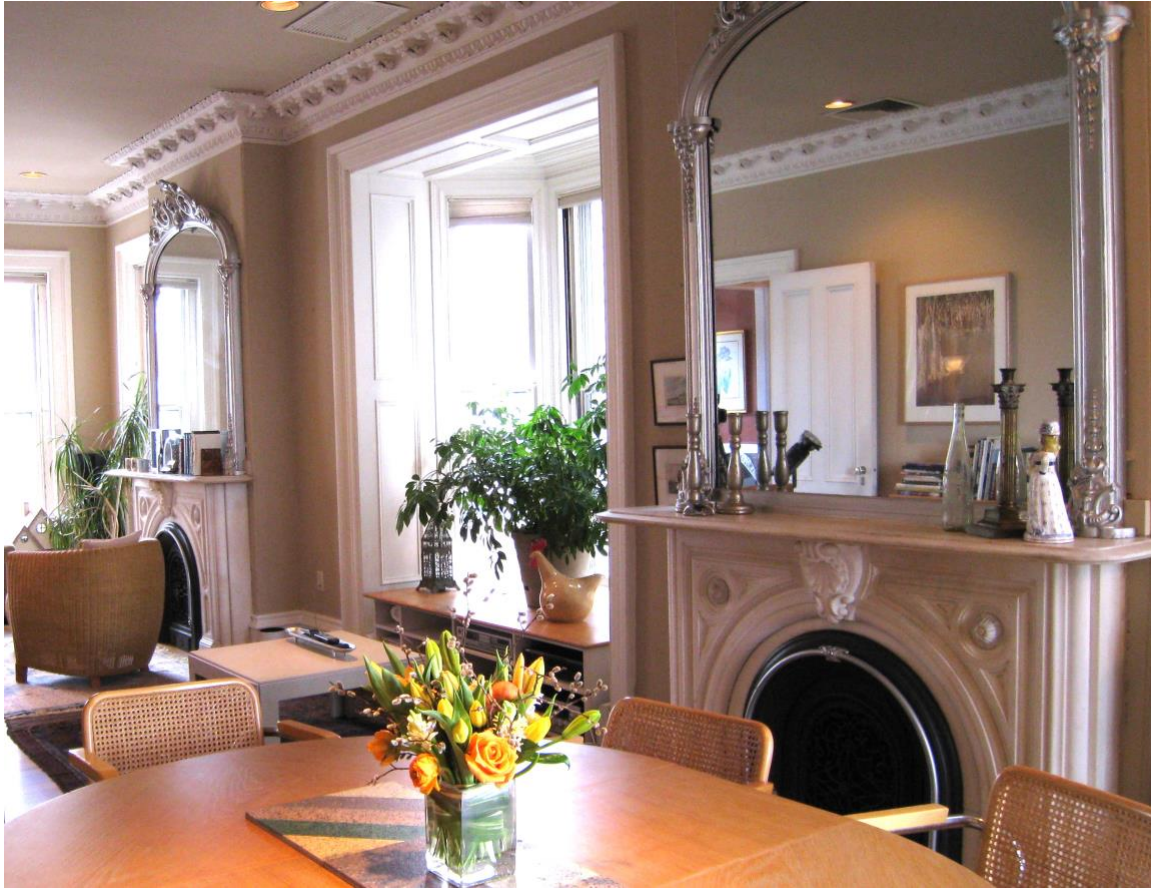
Double parlor, with mantels, mirrors, plaster cornice, first floor
